# MIDWEST FLOODS of 2008 & IN IOWA & WISCONSIN

## 3 Residential, Historic, and Commercial Buildings

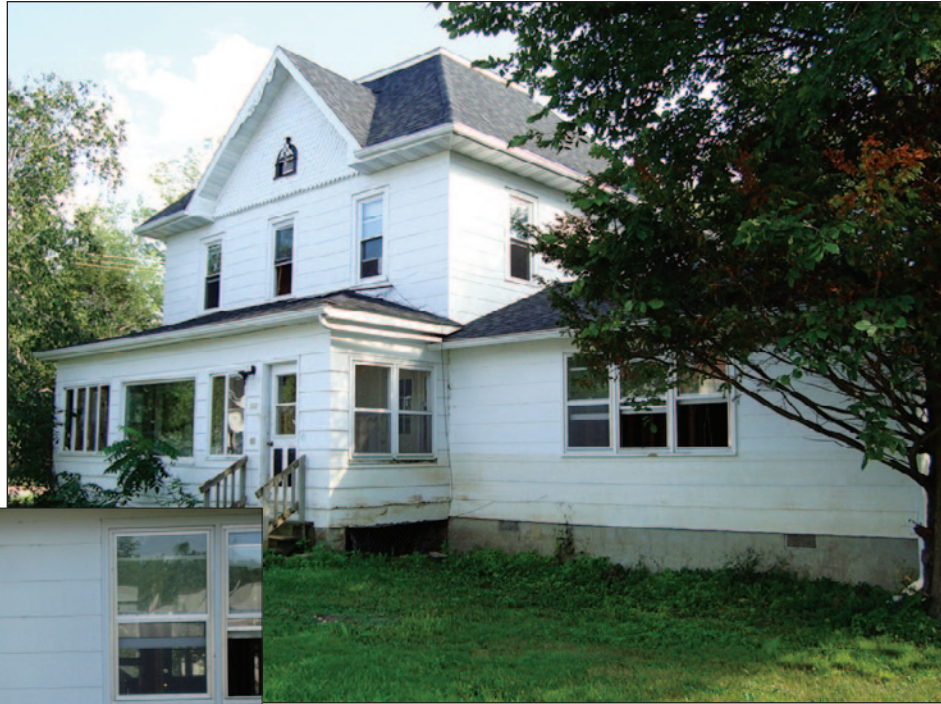
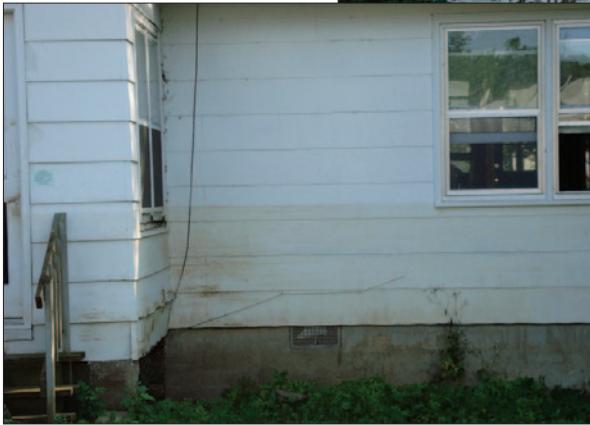
**Figure 3-57.**

This house located in the SFHA had openings for ventilation of the crawl space, but were too high to be compliant flood openings (Gays Mills, Wisconsin).

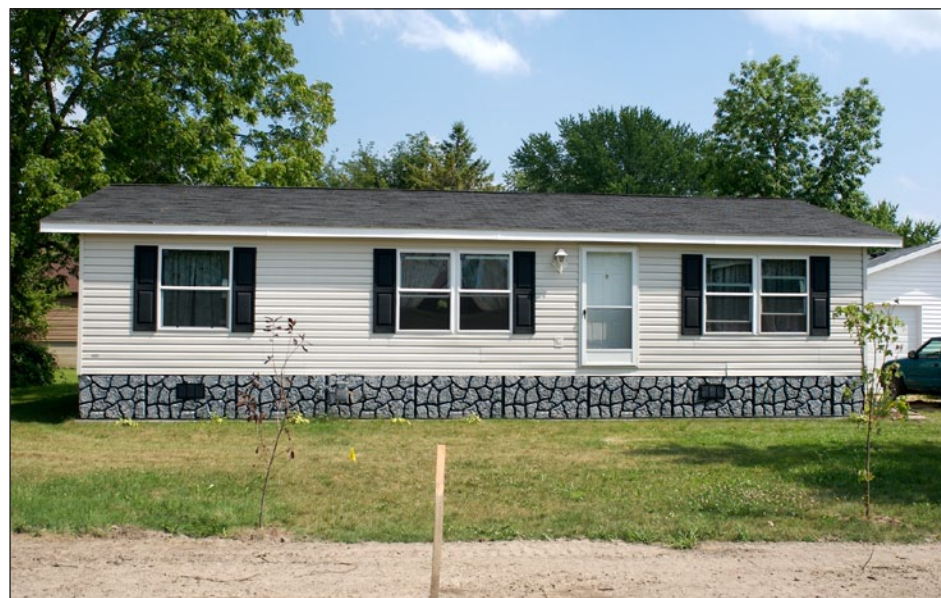
**Figure 3-58.**

This house located in the SFHA had openings installed within 12 inches of exterior and interior grade (La Valle, Wisconsin).

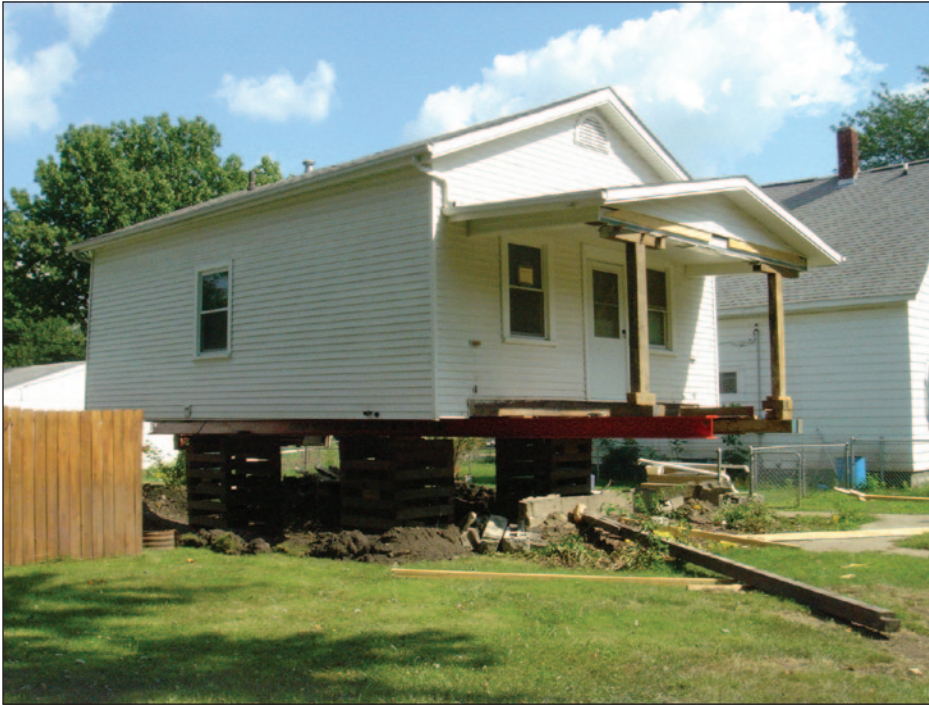
**Figure 3-59.**  
Existing house in the process of being elevated by homeowner (Cedar Rapids, Iowa).

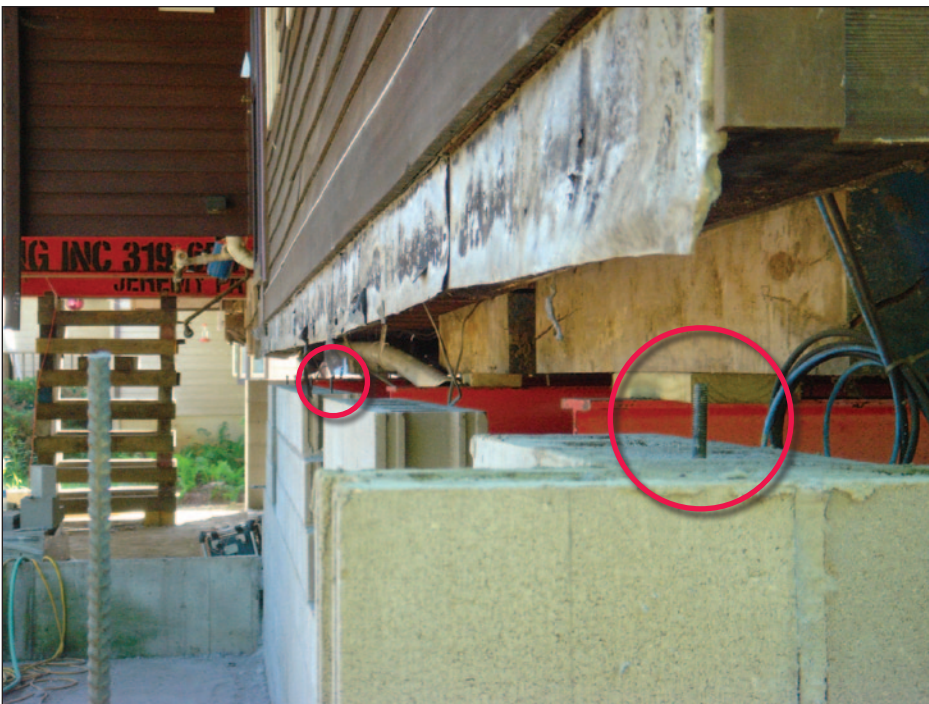
**Figure 3-60.**  
Most foundations were being built with anchor bolts to create a connection between the elevated house and the new foundation. For this project to be effective there must be a continuous load path and the use of frequently spaced reinforced cells in the block foundation walls. This house is located in the SFHA and is being elevated approximately 4 feet above the BFE (Iowa City, Iowa).

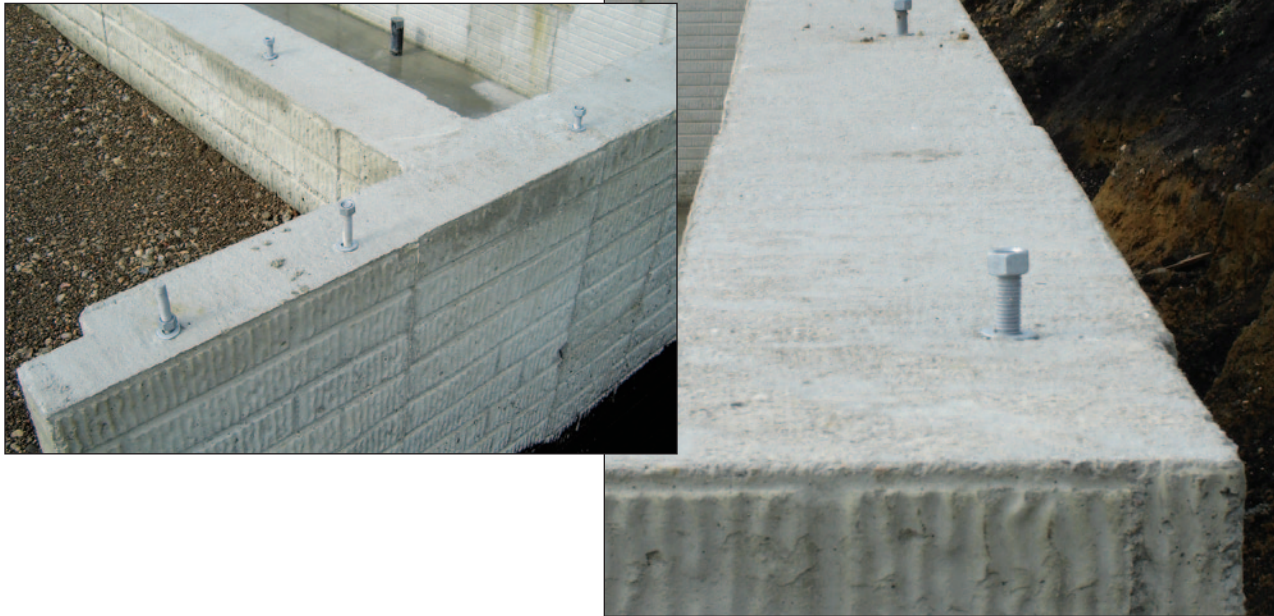
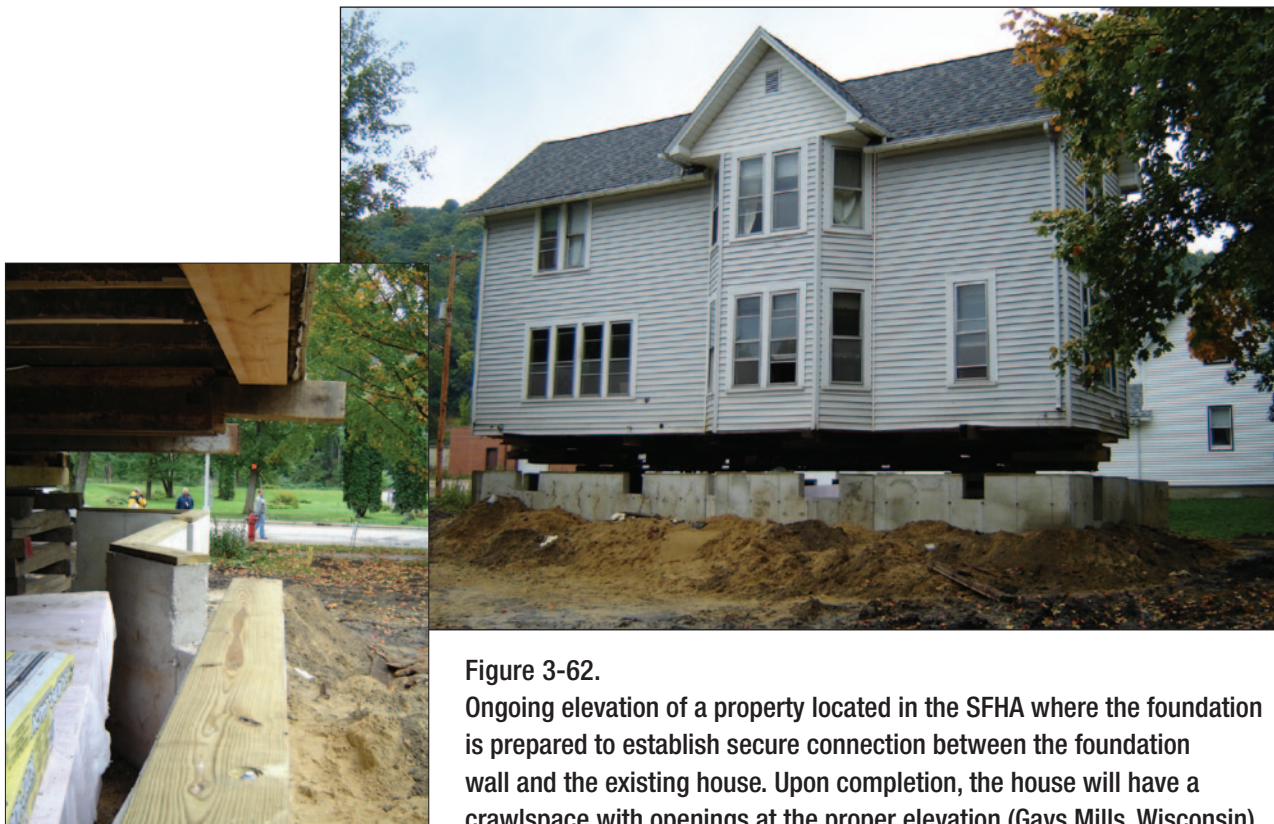
**Figure 3-61.**

This foundation has a well established layout for anchoring the sill plate. This connection is critical to the proper performance of the building in high-load events (Parkersburg, Iowa).

Ongoing elevation of a property located in the SFHA where the foundation is prepared to establish secure connection between the foundation wall and the existing house. Upon completion, the house will have a crawlspace with openings at the proper elevation (Gays Mills, Wisconsin).

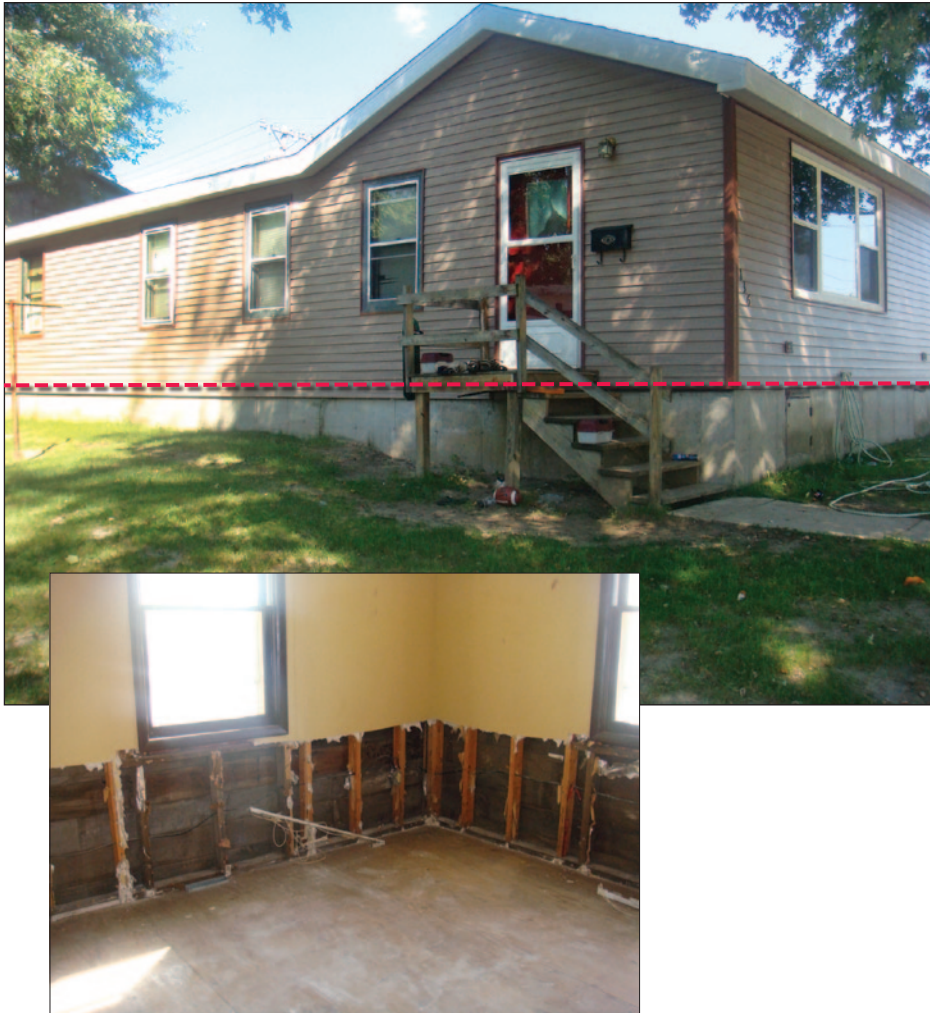
**Figure 3-63.** Structure in Reedsburg, Wisconsin, where the lowest floor is elevated 2 feet above BFE (red line shows the high water mark). The insert shows the interior of the adjacent pre-FIRM building had 3 feet of water above the first floor.

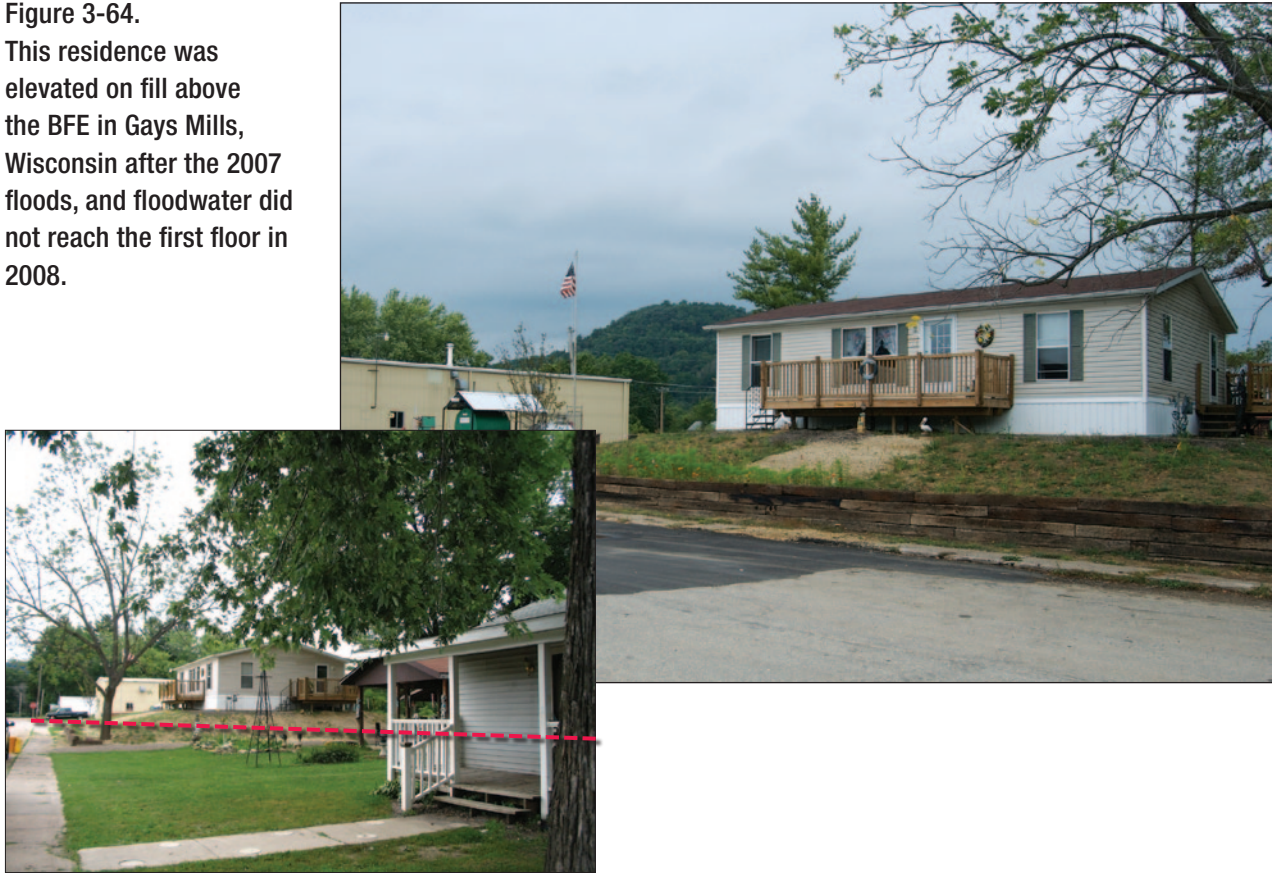
Figure 3-64.

This residence was elevated on fill above the BFE in Gays Mills, Wisconsin after the 2007 floods, and floodwater did not reach the first floor in 2008.

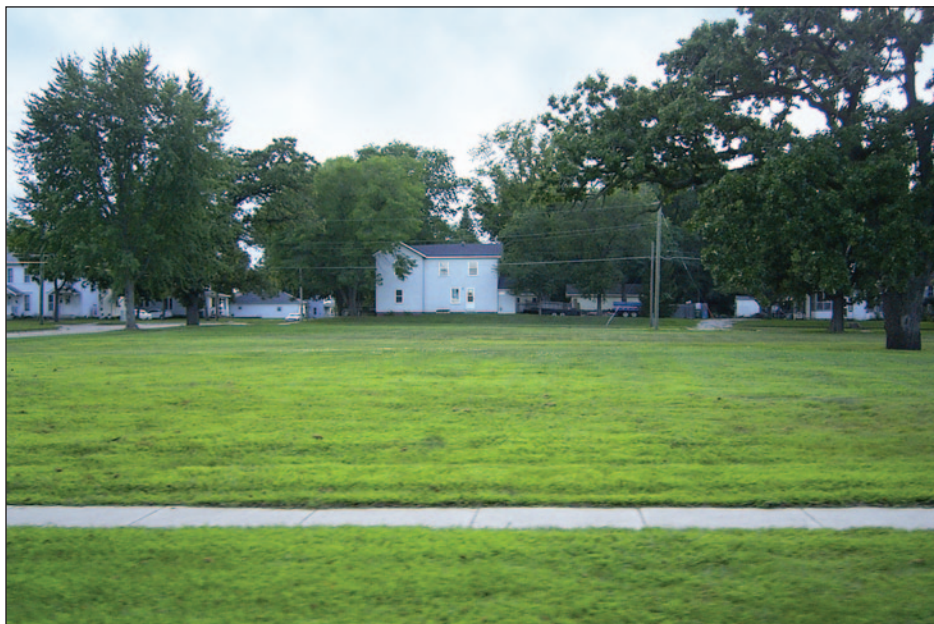
Figure 3-65. Site of a 1994 clearance project where multiple residential structures were acquired under the FEMA HMGP. This area is in the SFHA. Based on observed high water marks, it is estimated the acquired buildings would have had at least 1 foot of water in them (Independence, Iowa).

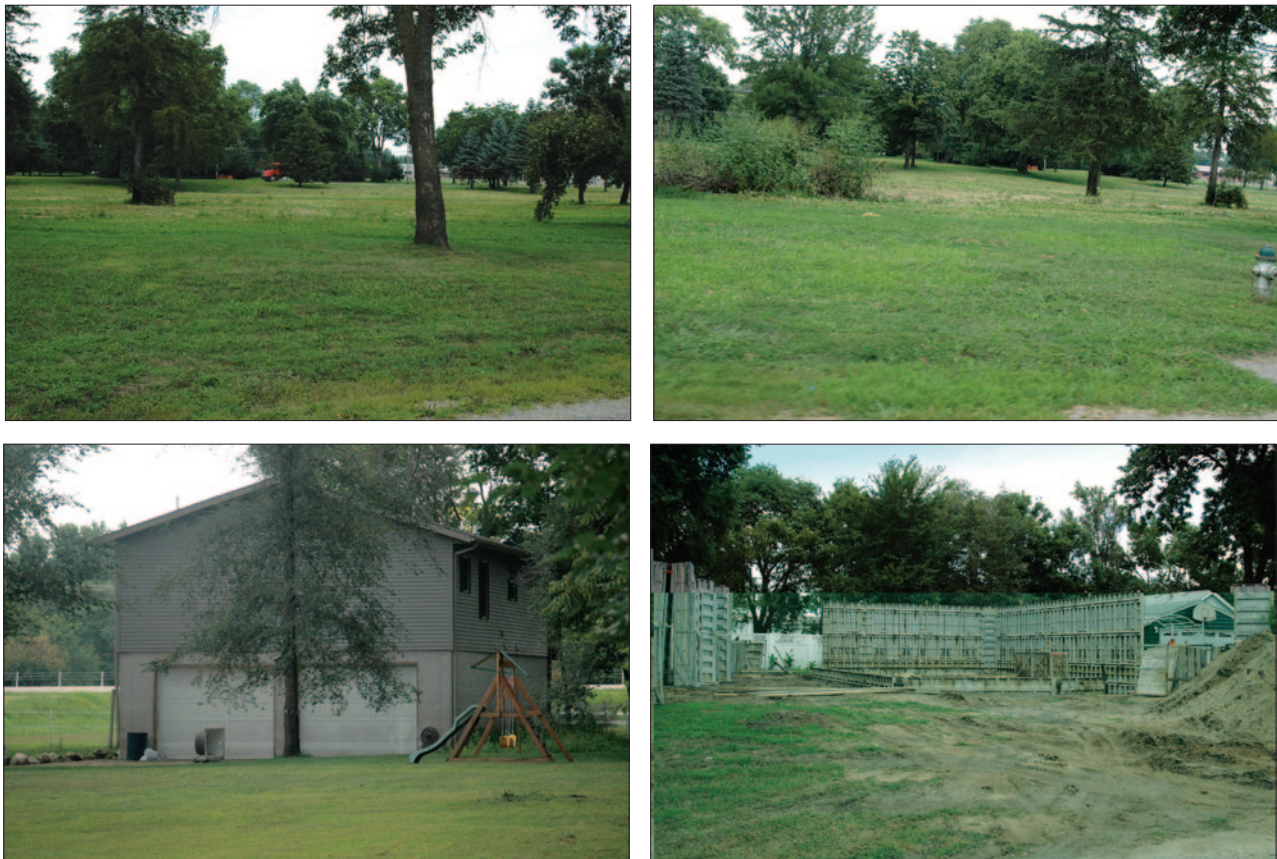
**Figure 3-67.**

The top photos show a project where the community acquired and relocated multiple residences in the SFHA. The lower left image is one of a few sporadic completed elevations in the same area, and the lower right is an ongoing elevation project (Cedar Falls, Iowa).

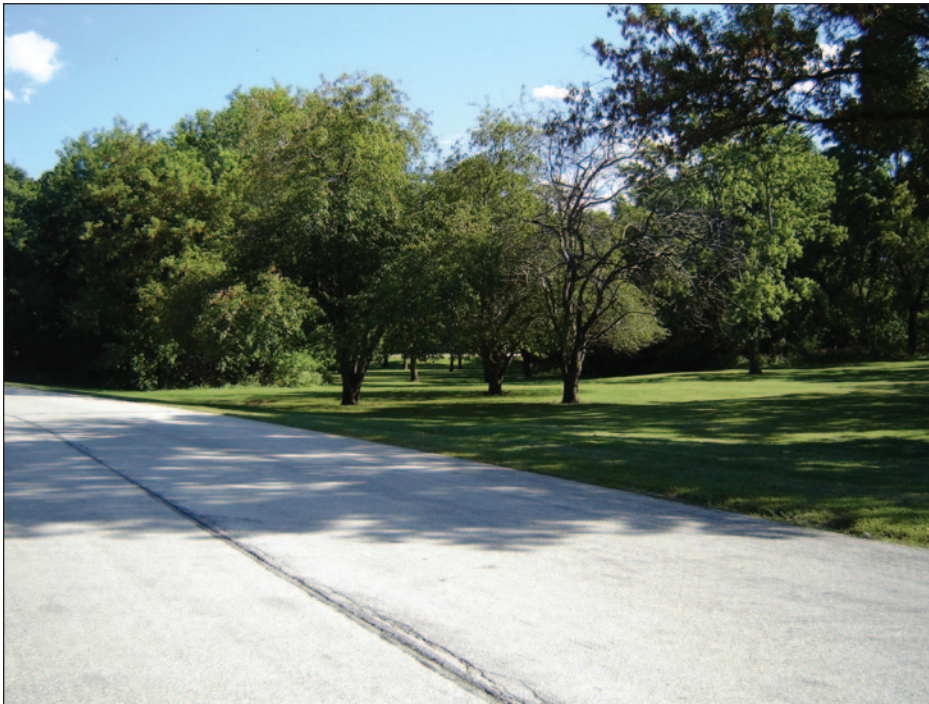
**Figure 3-68.**  
Site of successful acquisition of several houses in the SFHA. The acquisitions were completed using local funds to convert the area to open space. Had the houses remained in place, they would have been impacted by 1 to 2 feet of flooding in 2008 (Milwaukee, Wisconsin).

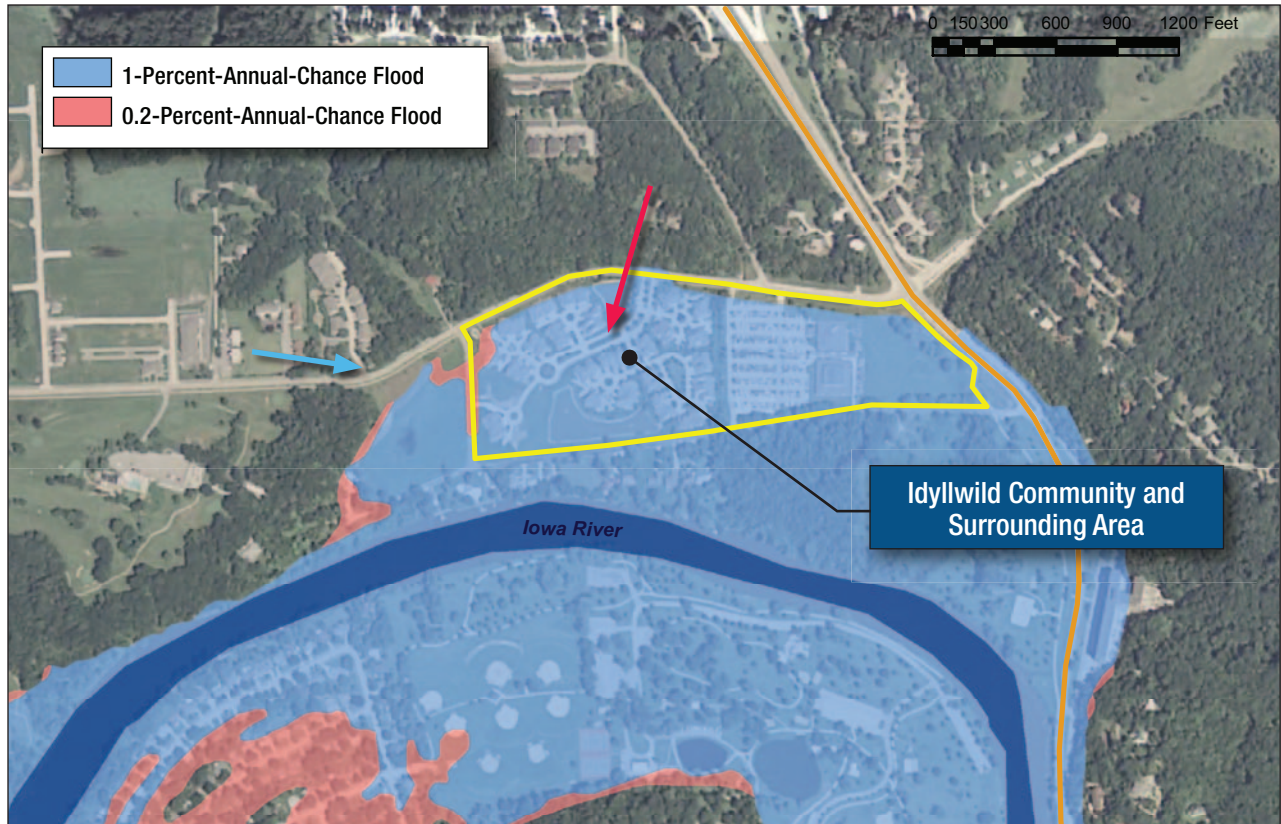
Figure 3-70.

This is the Idyllwild community (see red arrow) shown relative to the natural floodplain with the 1-percent and 0.2-percent-annual-chance floodplains highlighted without the elevation on fill being taken into consideration. The blue arrow is the position that the upper left photo in Figure 3-72 was taken from. This area experienced a <0.2-percent-annual-chance flood (Iowa City, Iowa).

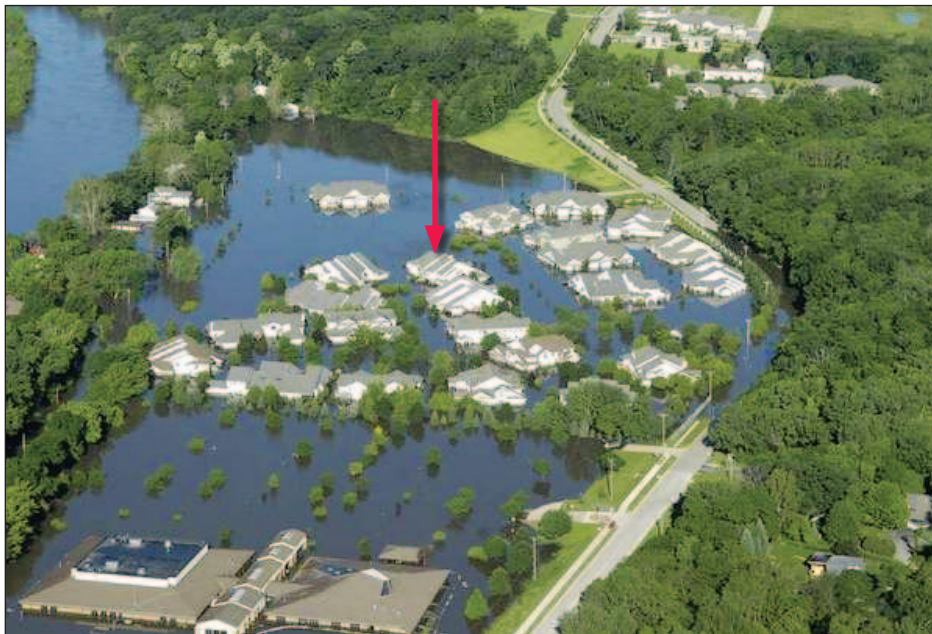
Figure 3-71.

This is the Idyllwild community (see red arrow) shown during the flood event. The red arrow is the location of the house shown in Figure 3-72 (Iowa City, Iowa).

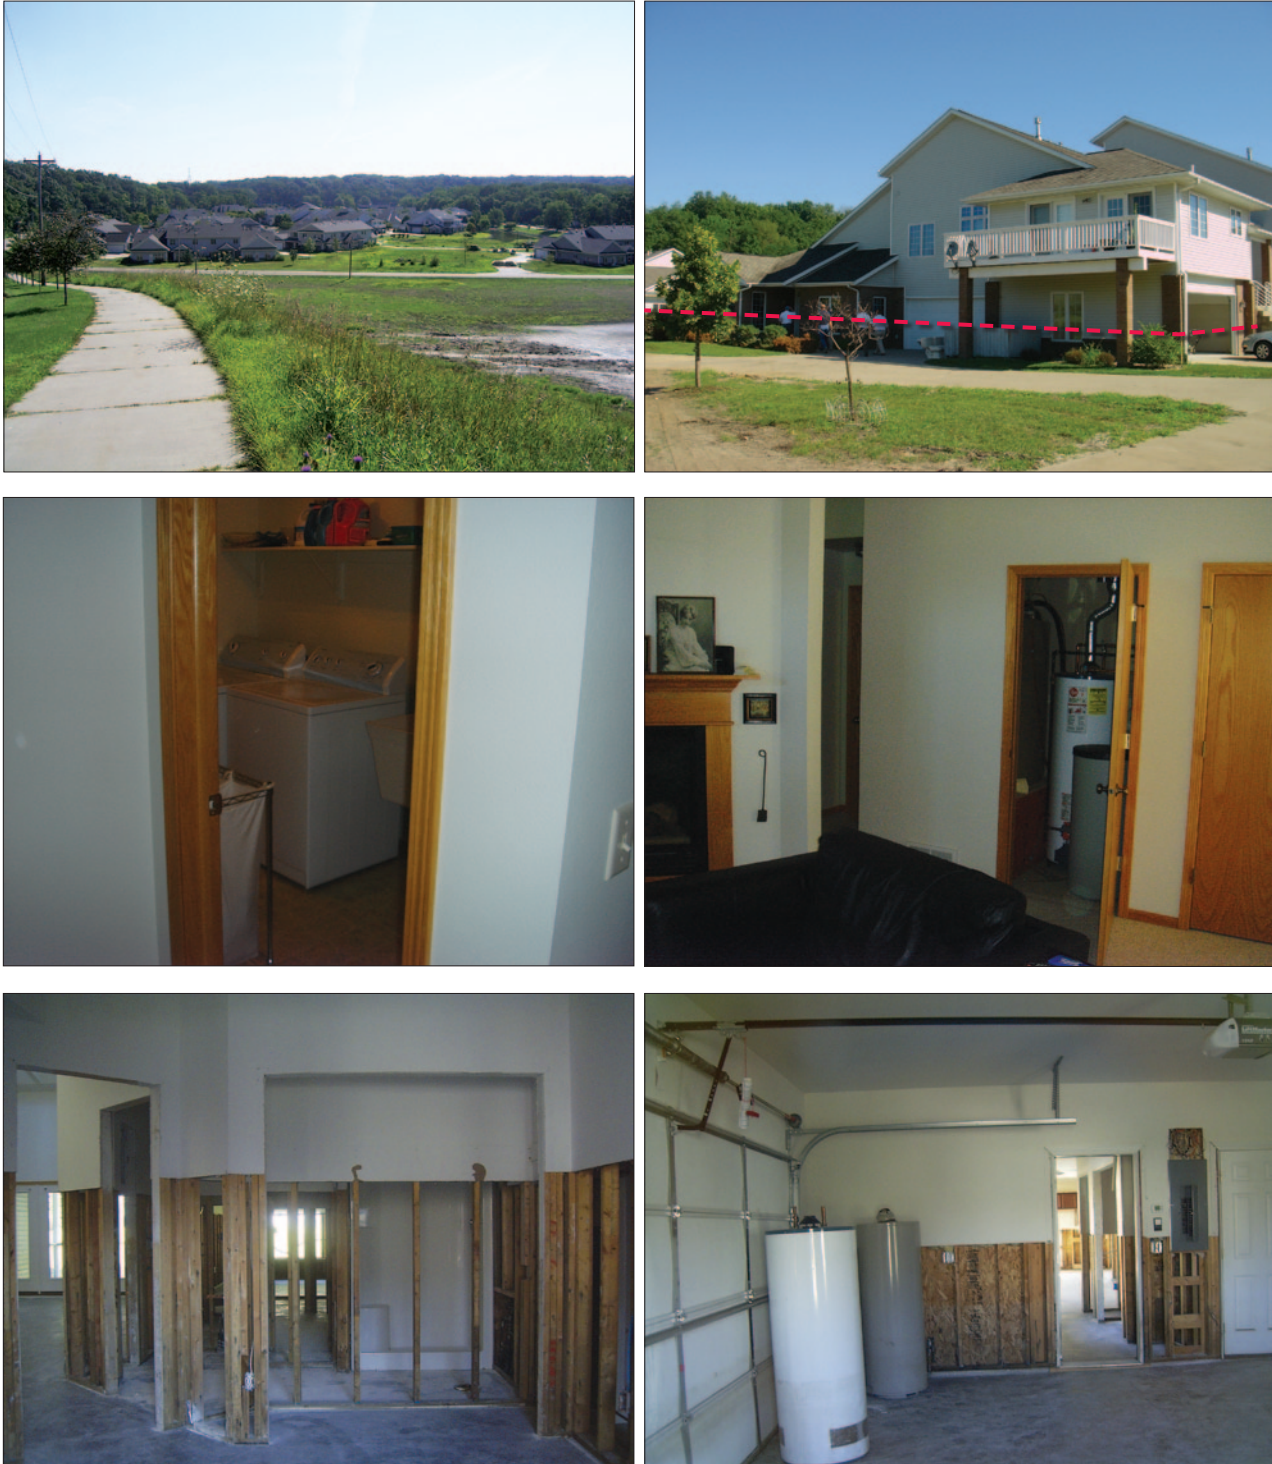
Figure 3-72.

Although most of the development was considered outside the floodplain based on a LOMR-F, it suffered extensive damages. (The LOMR-F is not reflected on the map shown in Figure 3-70.) The community spent over \$2 million in initial clean up costs to remove damaged contents and prevent further damage (e.g., mold); repair estimates require an additional \$10 million from property owners.

Site of a subdivision built on fill during the early 1990s, considered outside the floodplain based on LOMR-F. The dashed line in the upper right photo indicates the floodwater level. The center right and left photos show utilities located on the second floor level of the residence in the upper right photo. The bottom photos illustrate interior damage to the adjacent properties. The upper left photo was taken from the position noted in Figure 3-70 (Iowa City, Iowa).

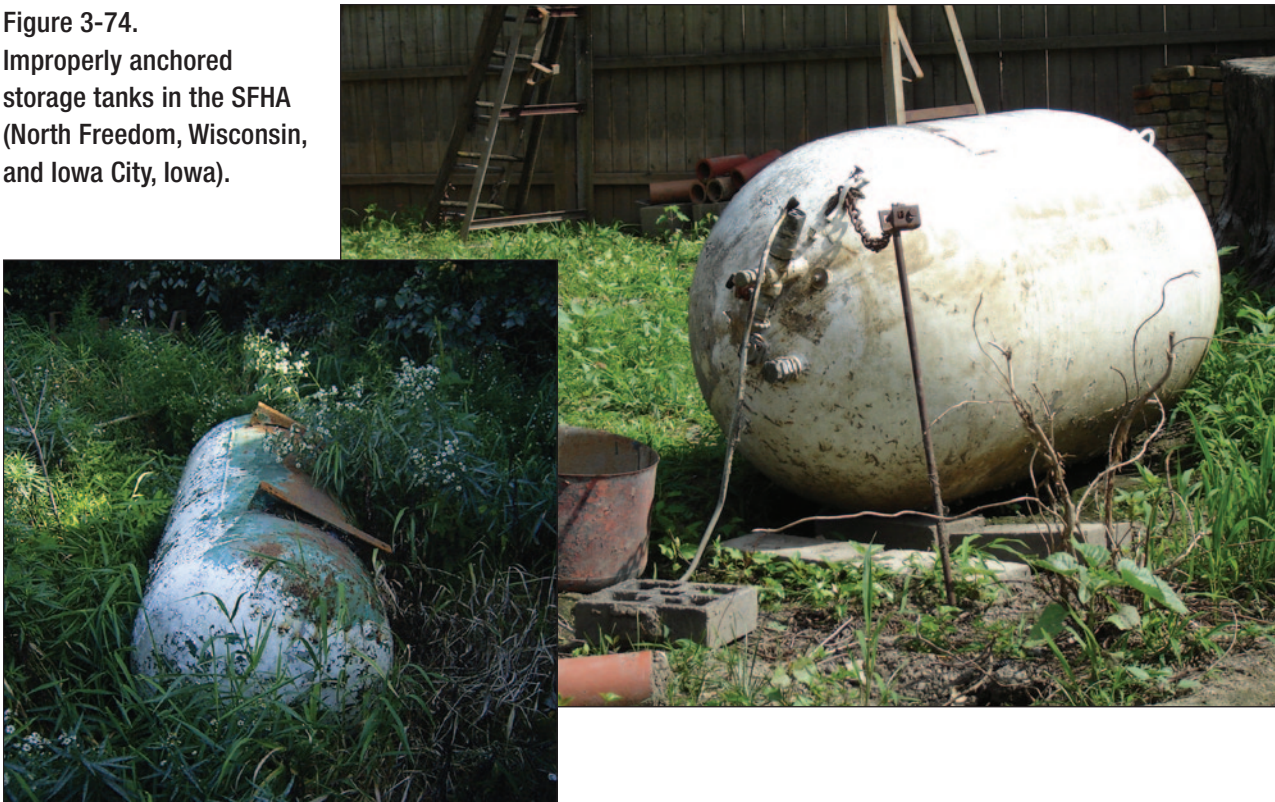
The NFIP requires that storage tanks be elevated above the BFE or be made watertight and anchored to resist floatation, collapse, or lateral movement resulting from hydrodynamic and hydrostatic loads, including the effects of buoyancy. The MAT observed numerous storage tanks throughout the communities visited that were not properly secured (see Figure 3-74). These unanchored tanks not only create more debris, but also generate a serious threat to public safety and the environment.

**Figure 3-74.**  
Improperly anchored  
storage tanks in the SFHA  
(North Freedom, Wisconsin,  
and Iowa City, Iowa).

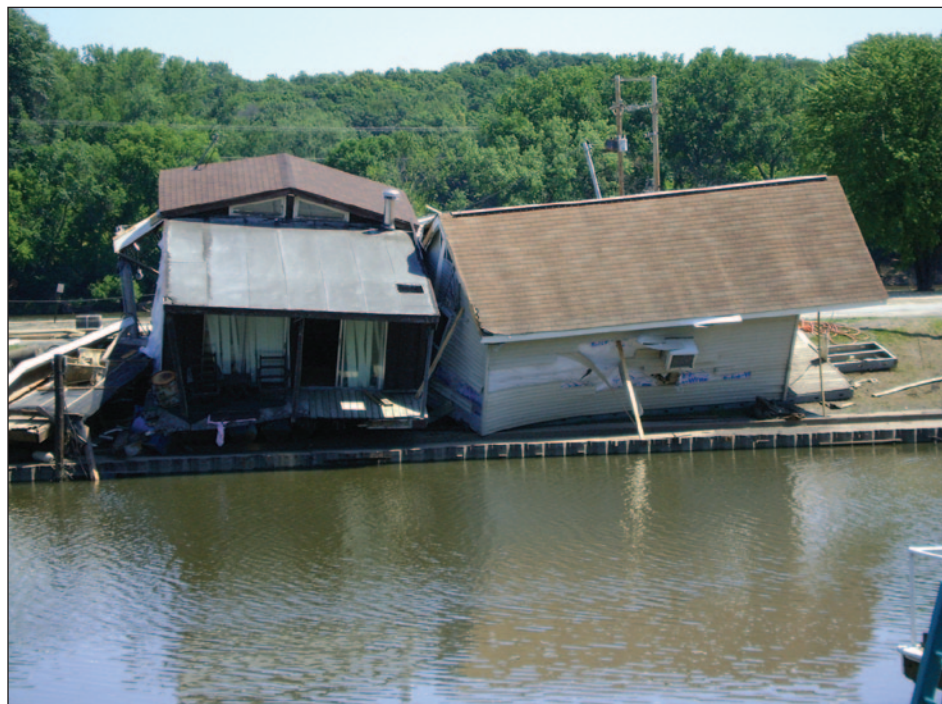
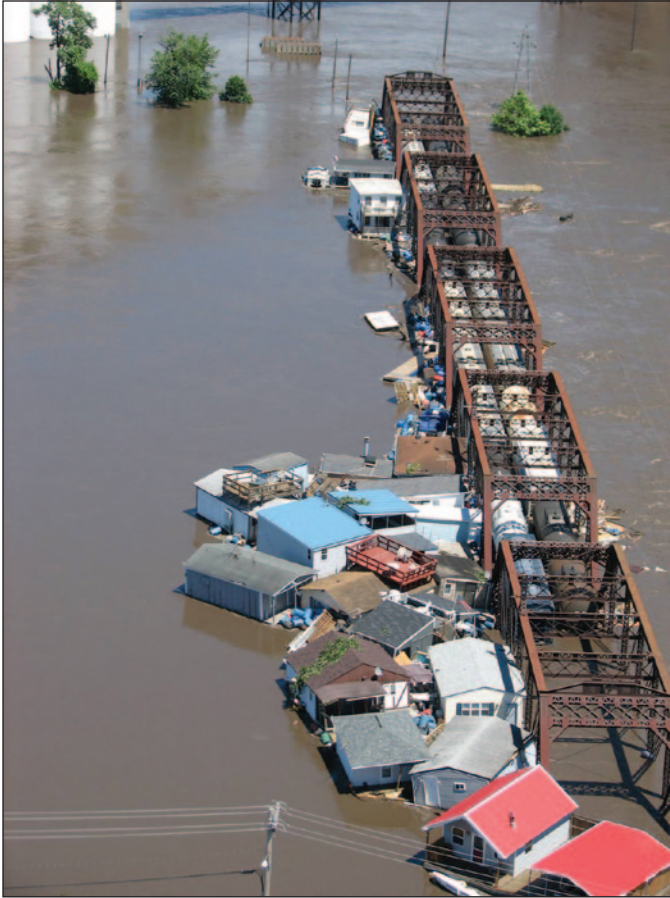
Figure 3-78.

Several houses were displaced downstream against a railroad bridge (Cedar Rapids, Iowa).

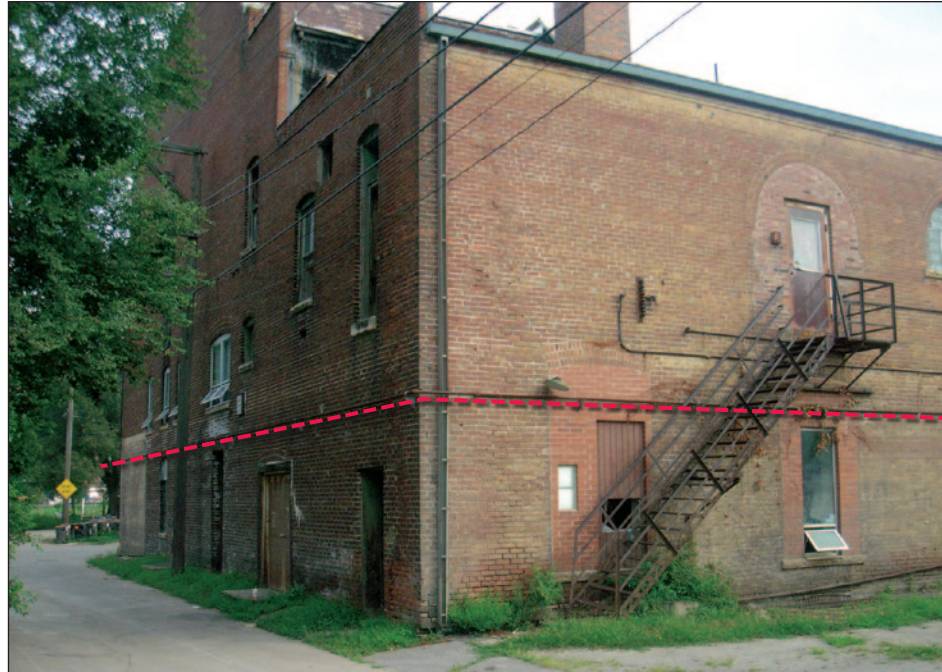
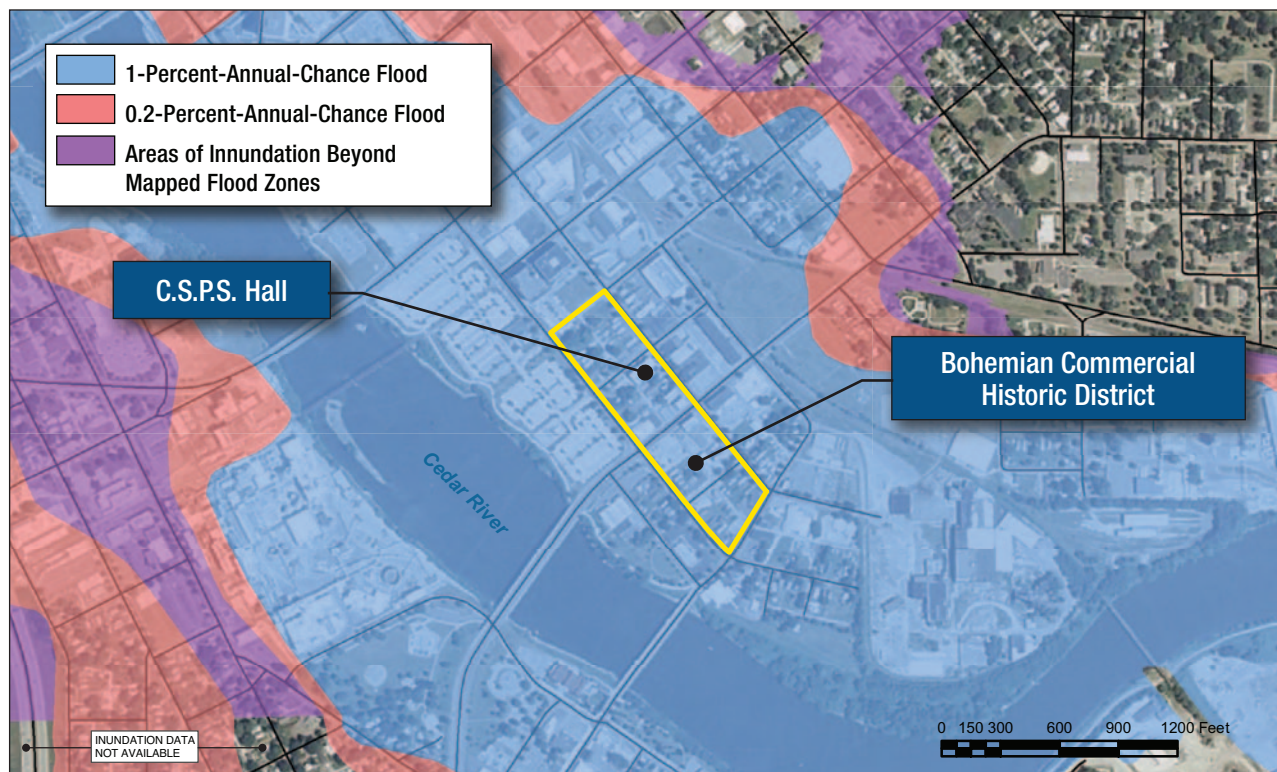
**Figure 3-79.**

This historic building (C.S.P.S. Hall) withstood approximately 8 feet of water (red line). This property, in an A11 flood zone, has a BFE of 722 feet, and a building elevation of approximately 720 feet (Cedar Rapids, Iowa).

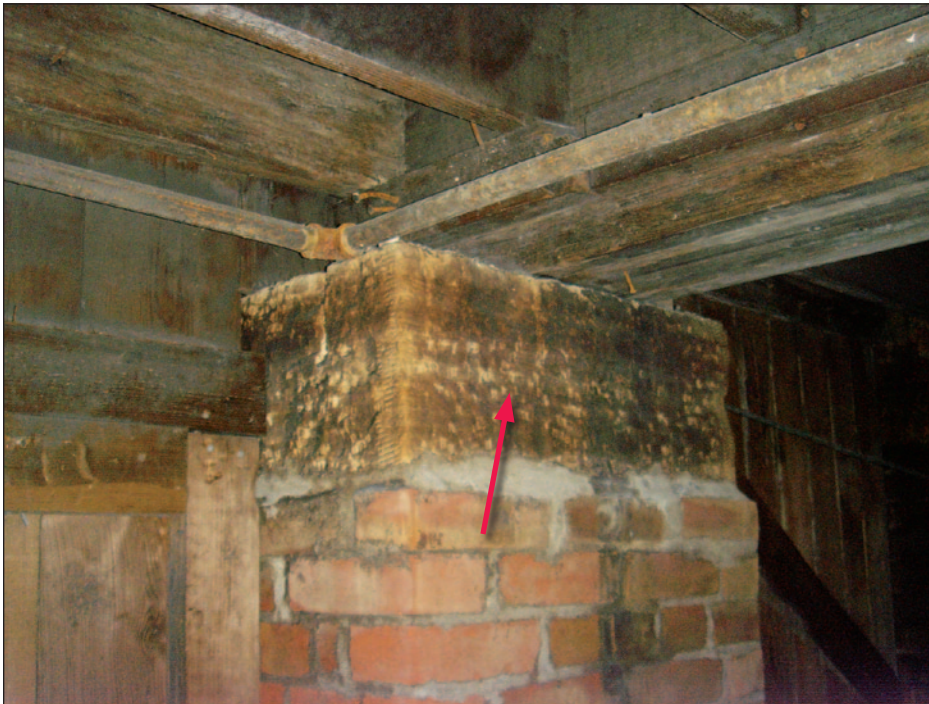
The foundation for the C.S.P.S. building appears to be in good condition after being dried out for several months. The hand-hewn stone cap block is in perfect condition. Effort should be made to dry-out and dehumidify the basement after this inundation, to ensure the wood framing returns to acceptable moisture content (see Figure 3-81).

**Figure 3-81.**  
Basement and foundation of historic building. The chisel marks in the hand hewn capstone (red arrow) are physical representations of the historic context of the building, the stone having been sized manually versus utilizing machinery (Cedar Rapids, Iowa).

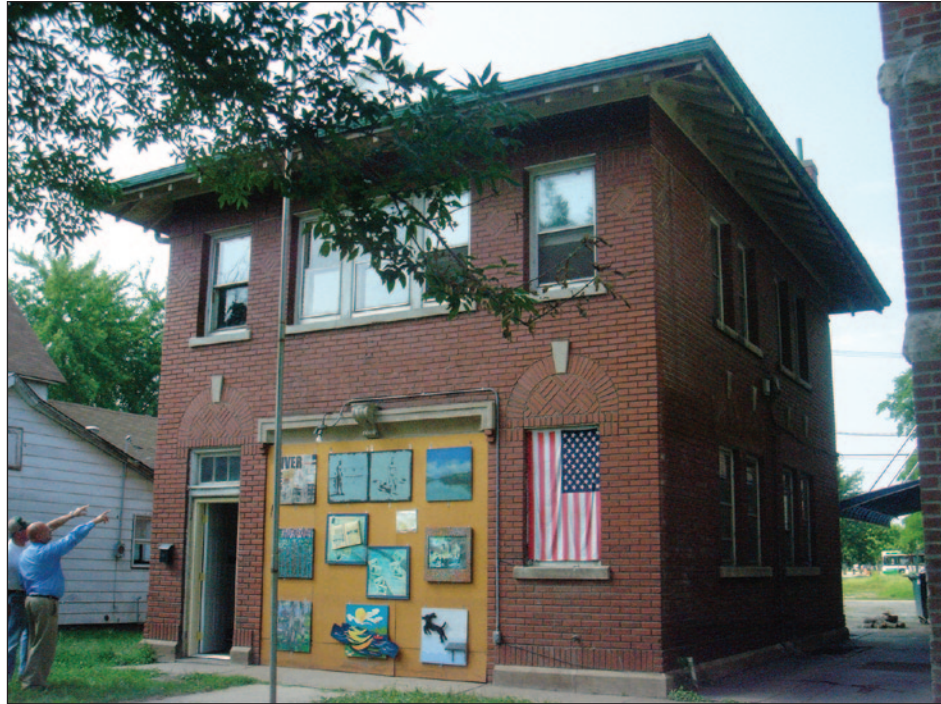
**Figure 3-82.**

This historic fire station's damage was limited to some broken windows and a damaged overhead door (Cedar Rapids, Iowa).

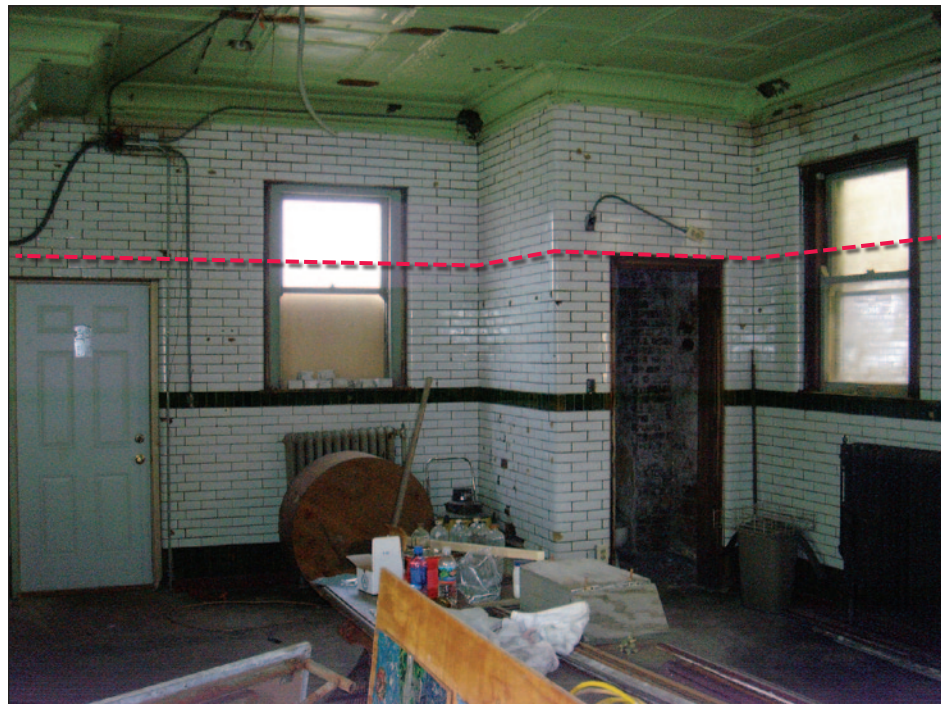
**Figure 3-83.**

The interior ground floor of this historic fire station was designed with glazed brick. This effectively wet floodproofed the building (Cedar Rapids, Iowa).

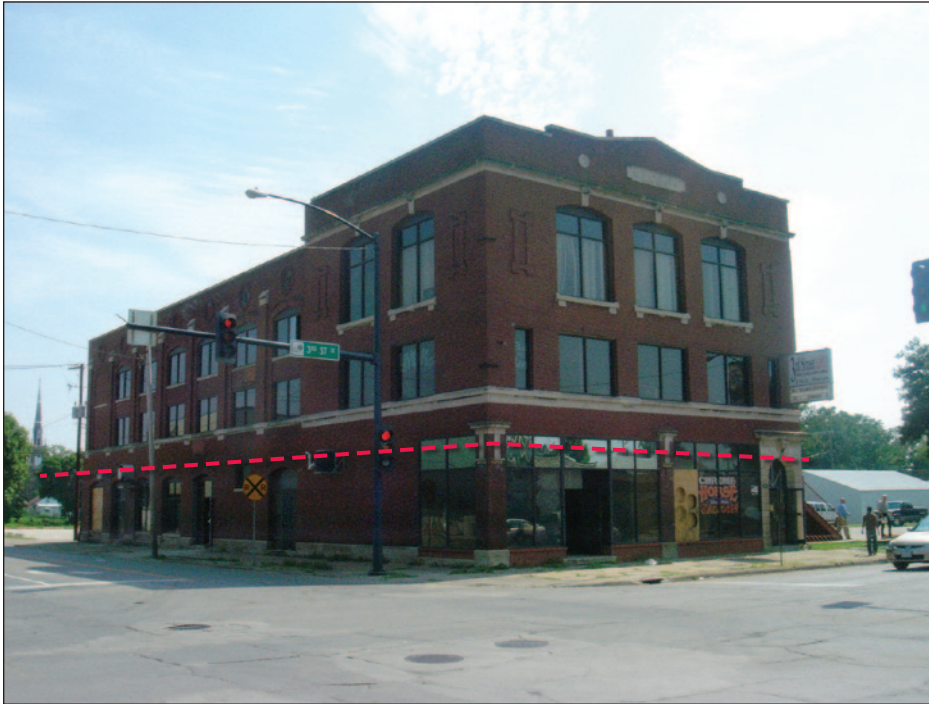
Figure 3-84.

This historic building had loss of the first floor furnishings, mechanical systems, electrical systems, and finishes due to 8 feet of water inundation (red line). This property, within the SFHA, has a BFE of 722 feet, and an elevation of approximately 720 feet. The upper floors survived intact (Cedar Rapids, Iowa).

structural components to dry. Care must also be given to treatment for decay and for wood-destroying organisms. A treatment and monitoring program should be implemented to verify these areas are properly de-humidified and no decay occurs. The damaged mechanical and electrical systems located on the first floor had to be replaced. Consideration should be given to locating the replacement equipment above the first floor, when possible and appropriate, to avoid future damage from flooding, as shown in Figures 3-84 and 3-85.

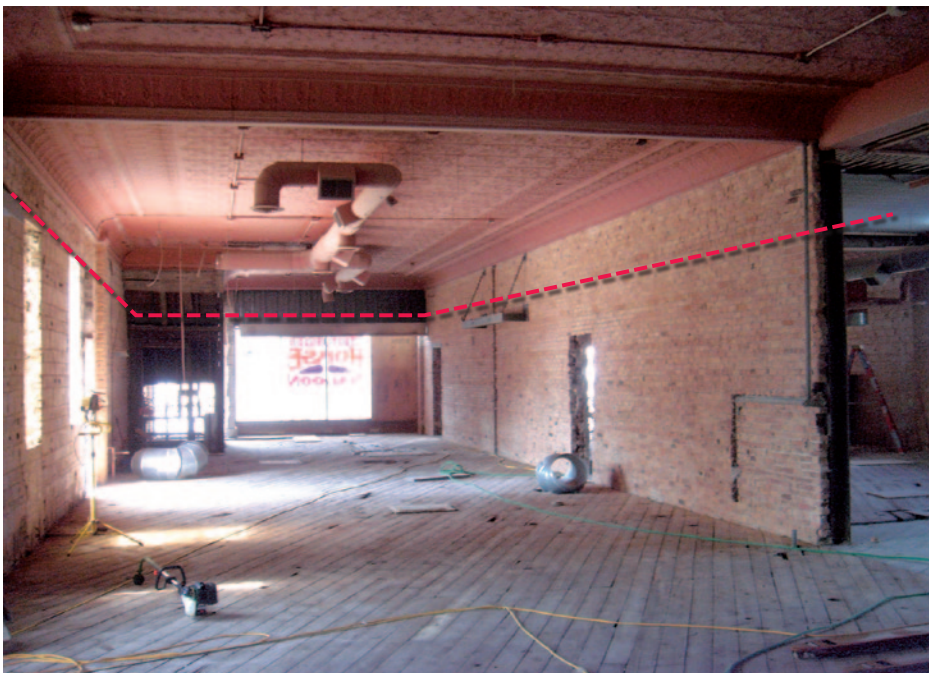
Figure 3-85.

The interior of the restaurant lost all interior elements up to about 8 feet above the floor (red line) (Cedar Rapids, Iowa).

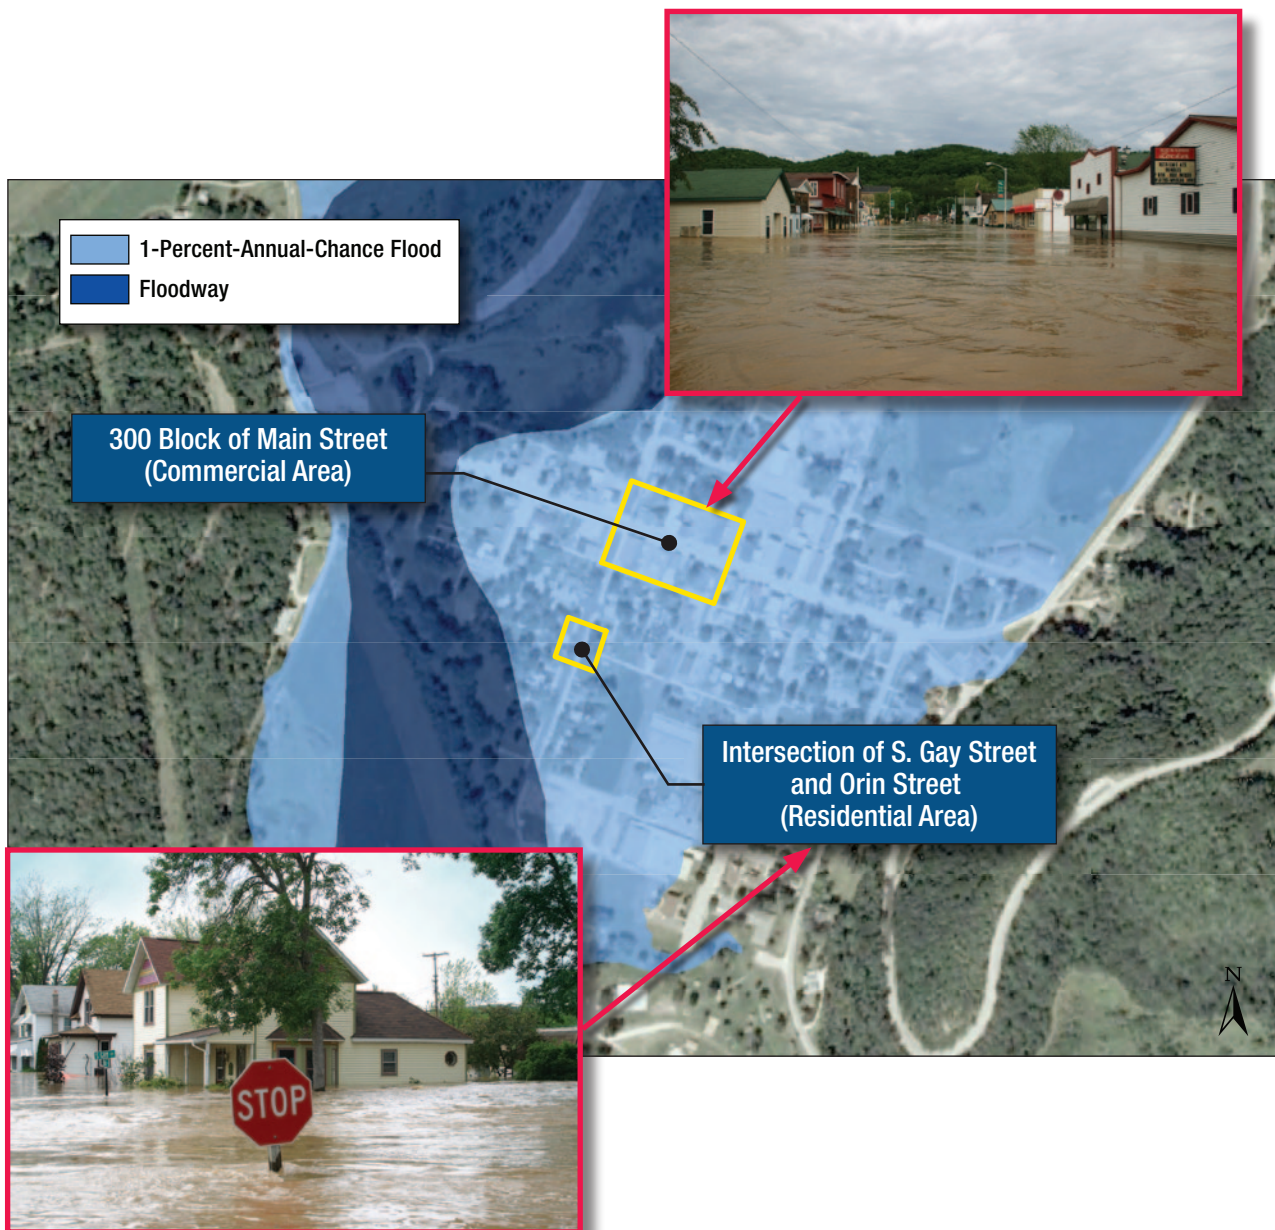
Figure 3-86. The Gays Mills downtown district had over 6 feet of water from the flood (Gays Mills, Wisconsin).
